# Radiometrics Corporation

## Quality Bulletin #QB01642009 05-Mar-2009

### IRT Corrosion, IRT Lens Pitting and IRT Reflective Mirror Degradation

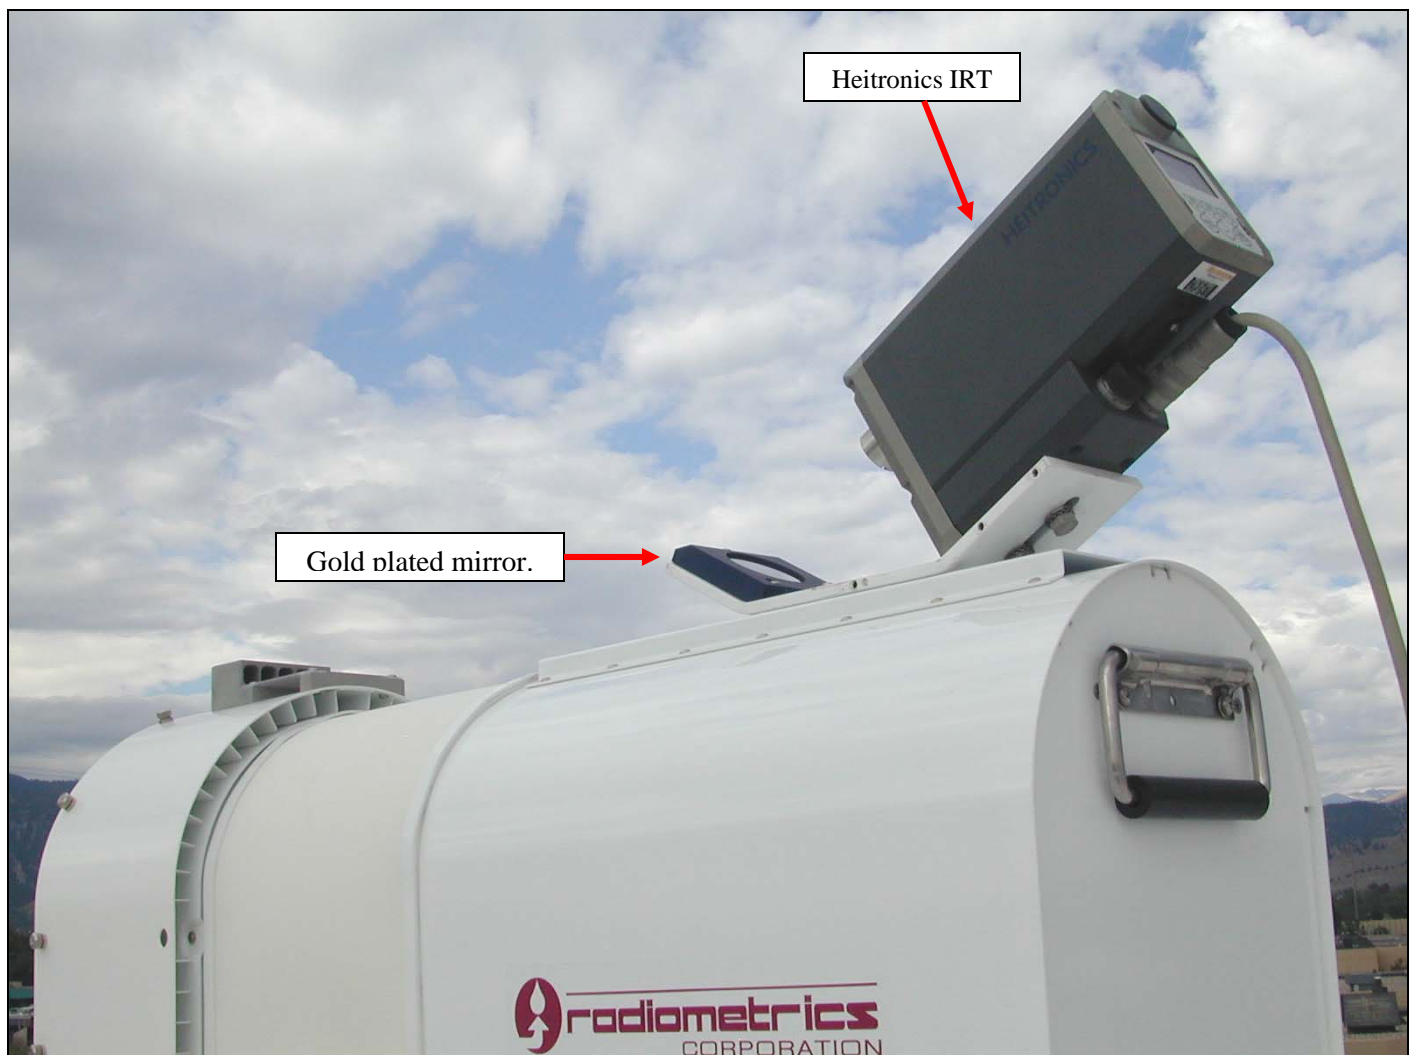
Figure 1. Older model radiometer shown with externally mounted IRT with IRT Cover removed.

Older models of radiometers were equipped with externally mounted Heitronics IRT’s and reflective gold plated mirrors as shown in Figure 1.

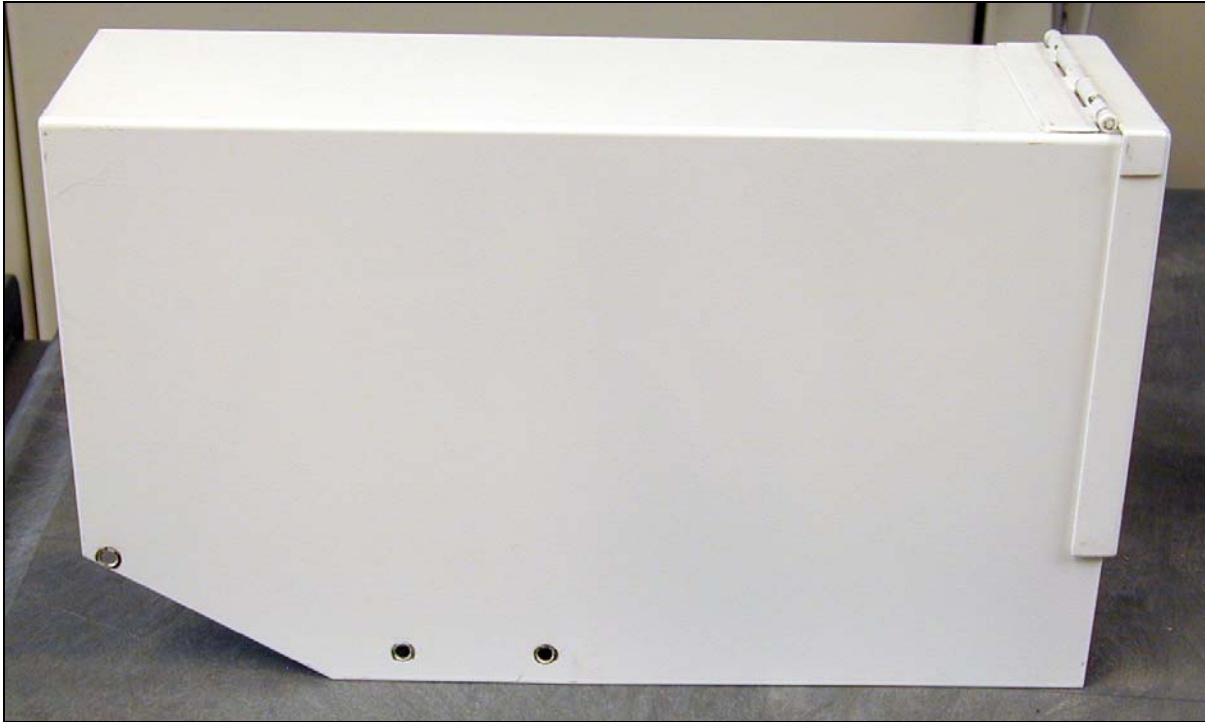
**Figure 2. IRT Cover used to provide additional protection for externally mounted IRT's.**

Even though the Heitronics IRT shown in Figure 1 was specifically designed for external mounting and was shrouded by the IRT Cover shown in Figure 2, environmental conditions eventually caused corrosion to the IRT outer housing, pitting of the IRT lens, corrosion of the IRT lens housing, corrosion of the IRT cable connector, degradation of the IRT cable jacket, degradation of the gold plated reflective mirror and overall poor performance resulting in compromised data.

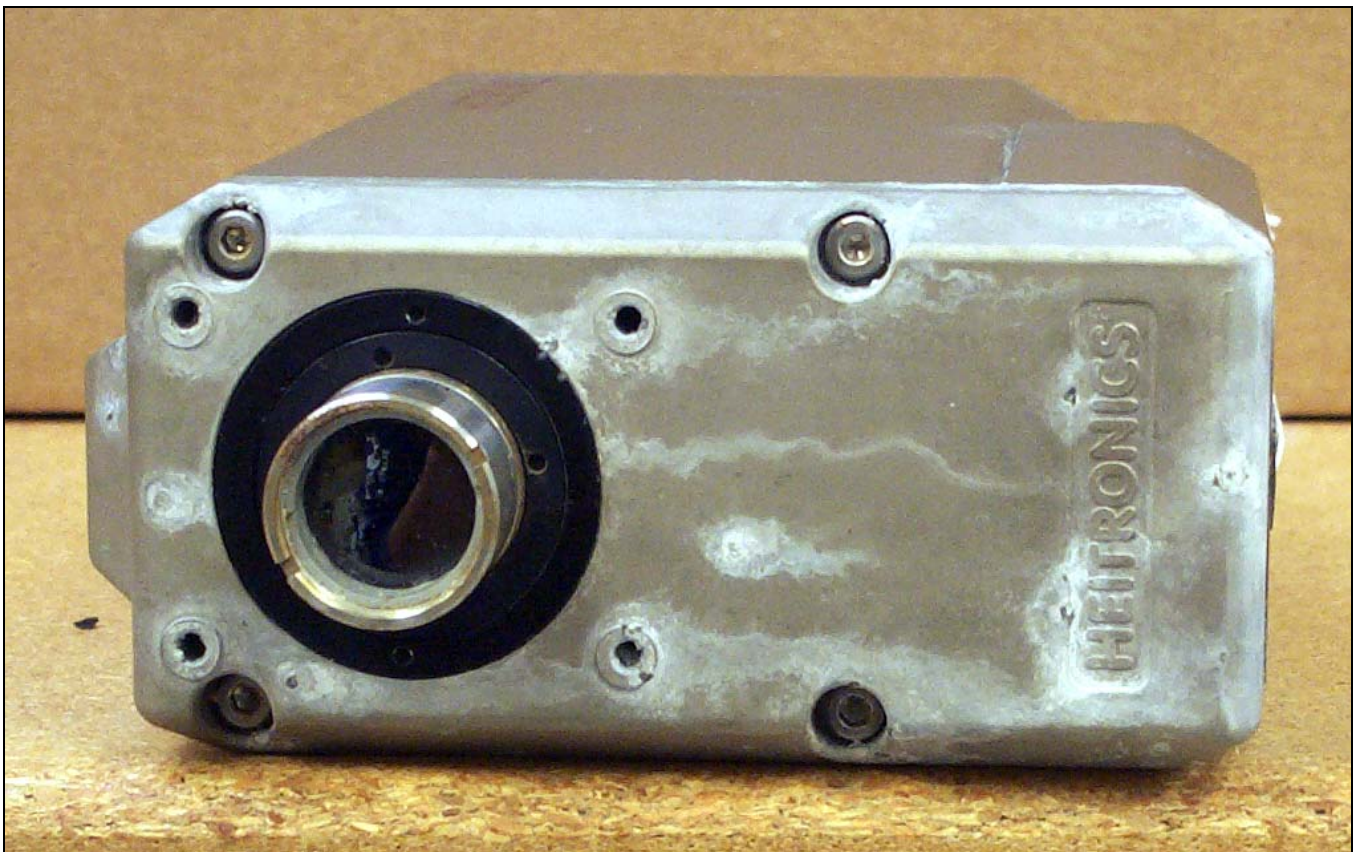
**Figure 3. Typical outer housing corrosion and oxidation observed on externally mounted IRT's.**

The typical corrosion and oxidation observed on externally mounted IRT outer housings is shown in Figure 3. The corrosion and oxidation on the IRT outer housing is mostly concentrated on the unpainted aluminum front and back plates. This unacceptable condition will compromise the seals in the IRT assembly, invade the IRT internal circuitry as shown in Figure 4 and Figure 5, and ultimately lead to catastrophic failure of the IRT.

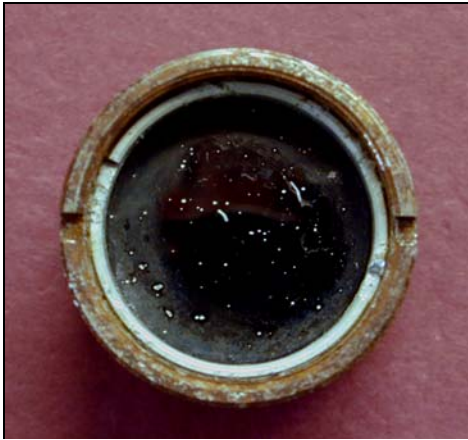
**Figure 6. IRT lens showing lens pitting and lens housing corrosion.**

Even in instances where the corrosion and oxidation has not managed to invade the IRT's inner electronic assemblies, externally mounted IRT's are compromised by pollutant build-up on the IRT lens and pitting of the IRT lens as shown in Figure 7, Figure 6 and Figure 9. Typically, any model of externally mounted IRT lenses will need to be replaced, due to excessive pitting and lens coating failure, as soon as (if not before) the IRT lens housing exhibits the type of corrosion and oxidation seen in Figure 6, Figure 9 and Figure 8. The externally mounted gold plated mirror (used to reflect the overhead view into the IRT lens), regardless of the plating thickness and/or manufacturer it is purchased from, will also succumb to the environmental conditions and eventually exhibit similar degradation as shown in Figure 10.

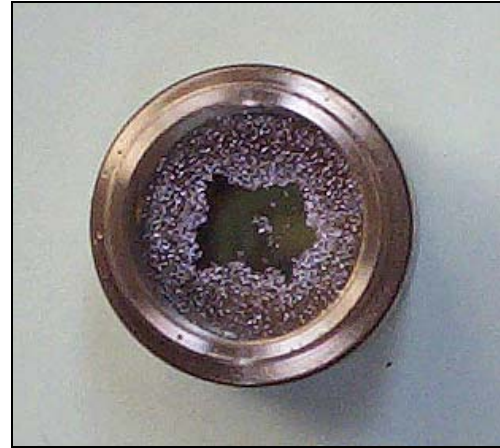
**Figure 7. IRT lens showing lens pitting and extreme failure of lens coating.**

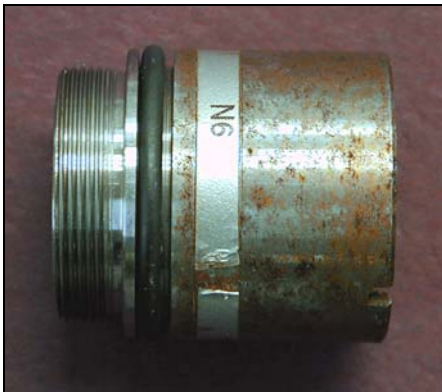
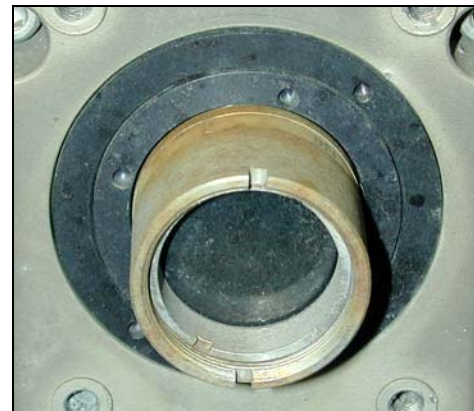
**Figure 9. IRT lens showing pollutant build-up and corrosion of lens housing.**

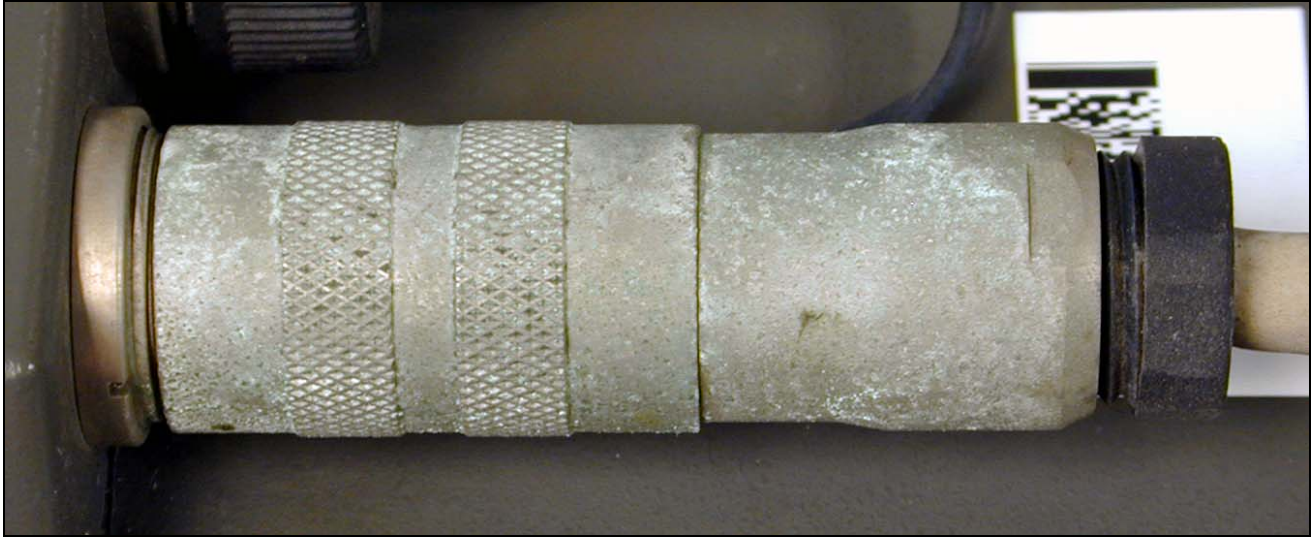
Externally mounted IRT's also experience electronic failures directly attributed to ultraviolet degradation of the IRT cable outer jacket and corrosion/oxidation of the cable connector as shown in Figure 11.

**Figure 11. IRT cable connector housing showing corrosion and oxidation.**

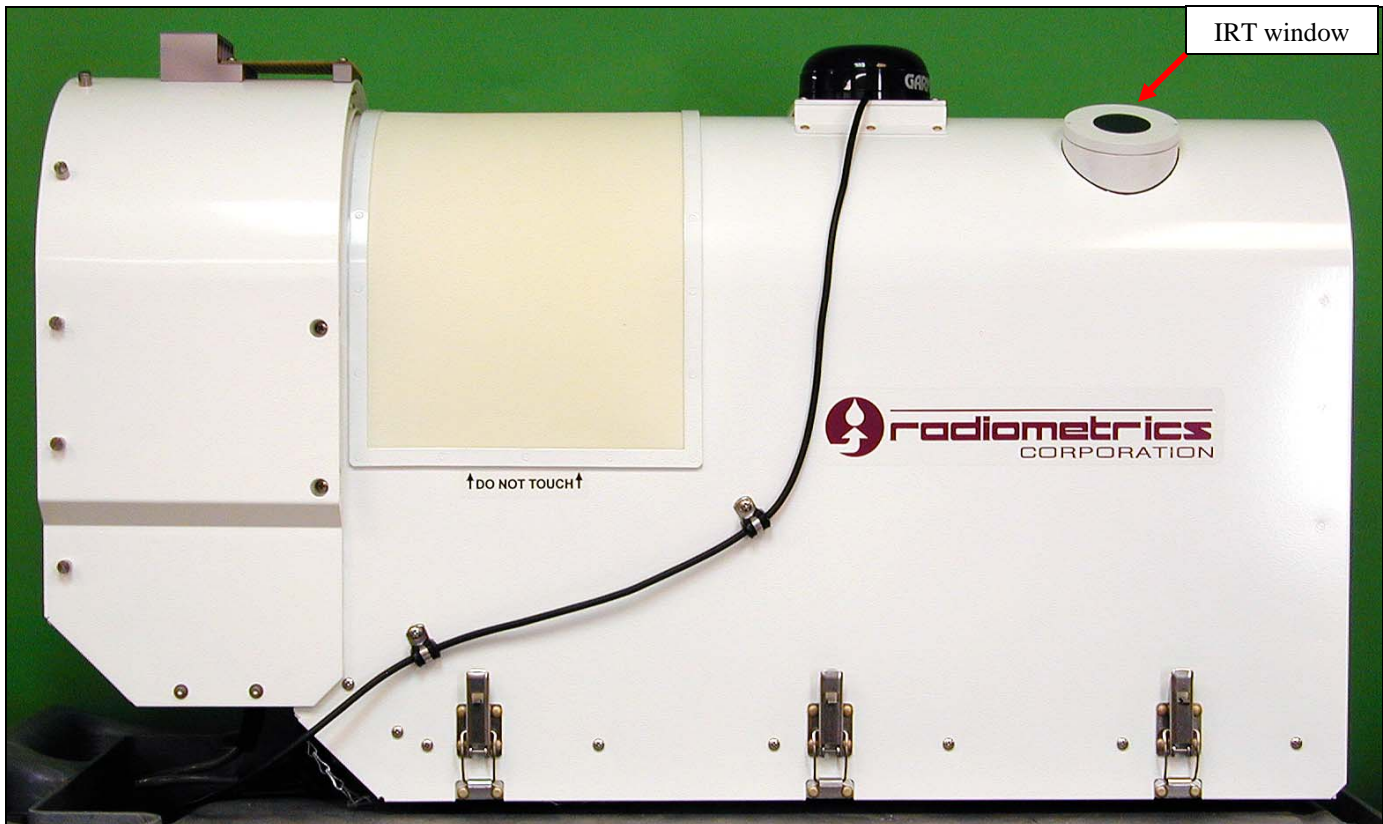
**Figure 12. "A Series" radiometer cabinet hood view with IRT window.**

All of the aforementioned problems, unacceptable conditions and failure modes have been eliminated as evidenced through nearly four years of successful "A Series" radiometer deployments in the harshest environments around the world. The "A Series" design (shown in Figure 12 and Figure 13), with the IRT completely protected inside the cabinet hood, has eliminated all IRT lens, lens housing, cable, cable connector and catastrophic IRT electronics failures and has significantly reduced customer maintenance costs. The complete elimination of the IRT mirror has reduced costs and eliminated one variable affected by pollutant buildup and degradation. The hardened coating on the "A Series" IRT window is significantly more robust against pollutants as proven through extensive operation in polluted and corrosive environments like Beijing, China, and on the deck of ocean-going vessels (e.g. University of Manitoba - Hanesiak).

It should be noted that all failures associated with the externally mounted IRT "shut-downs" (caused by operation in cold temperature extremes) have been eliminated due to the thermally controlled environment inside the "A Series" cabinet hood. Also, the "A Series" internally mounted IRT design ensures that customer data is no longer compromised by snow and moisture accumulation on the IRT lens.
